Manhole Inspection Summary

Manhole # S05EE2003MH

Location Address: **2714 BARTOL AVE**

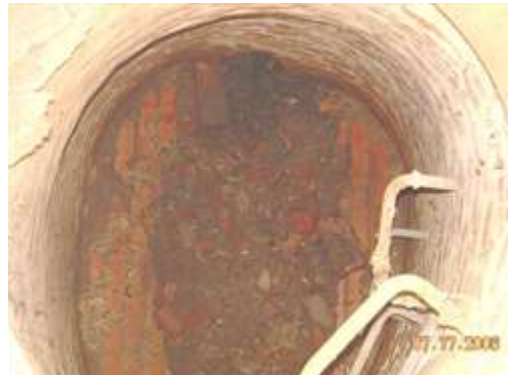
Top View

Frame leaks. Adjustment deterioration and loose brick. Adjustment infiltration. Channel debris.

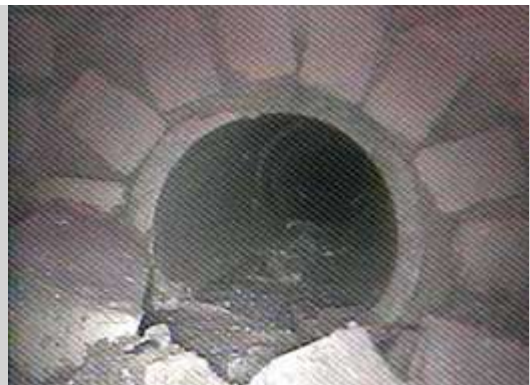
Pipe Out @ 12 O'Clock

Deposits: ☐ None ☒ **Mud** ☐ Sludge ☒ **Debris** ☐ Grease

Infiltration: **Evidence**
